6 September 2002

Work Order # 12634.001.001.0289.00  
TDD # S05-0207-012  
DCN: 289-2A-ACBX

Re: Acme Steel Company Site Assessment, Riverdale, Illinois

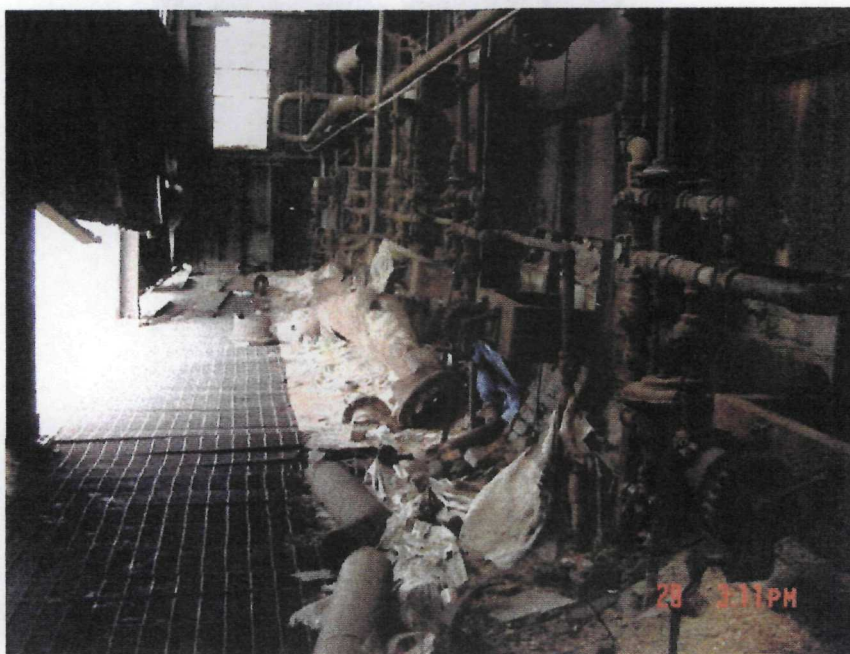
**SUBJECT:** Southeast end of Building 9, entryway.

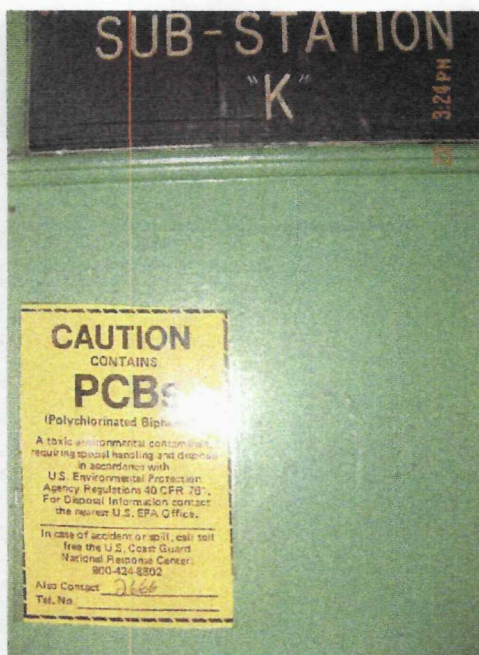
**SUBJECT:** Substation K, Transformer PCB warning in Building 9.

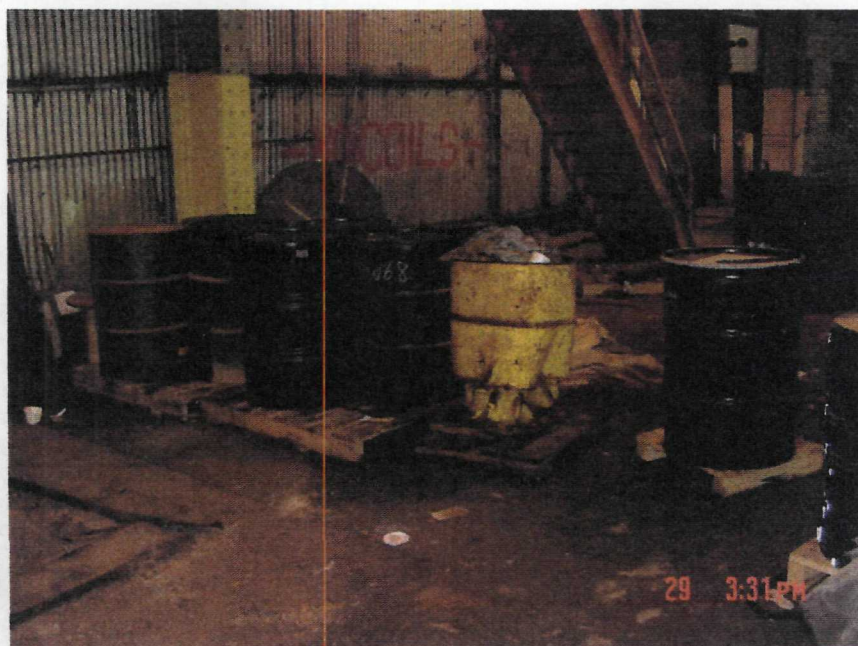
**SUBJECT:** Grease drums along southwest wall (pillar DA31 to right is not shown) in Building 9.

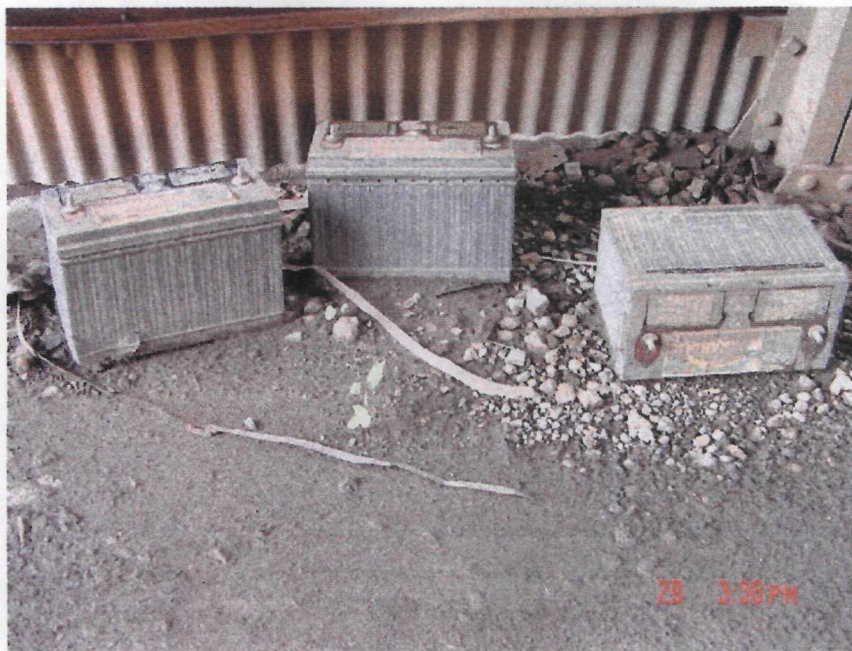
SUBJECT: Waste batteries between railroad tracks and south wall in central portion of Building 9.

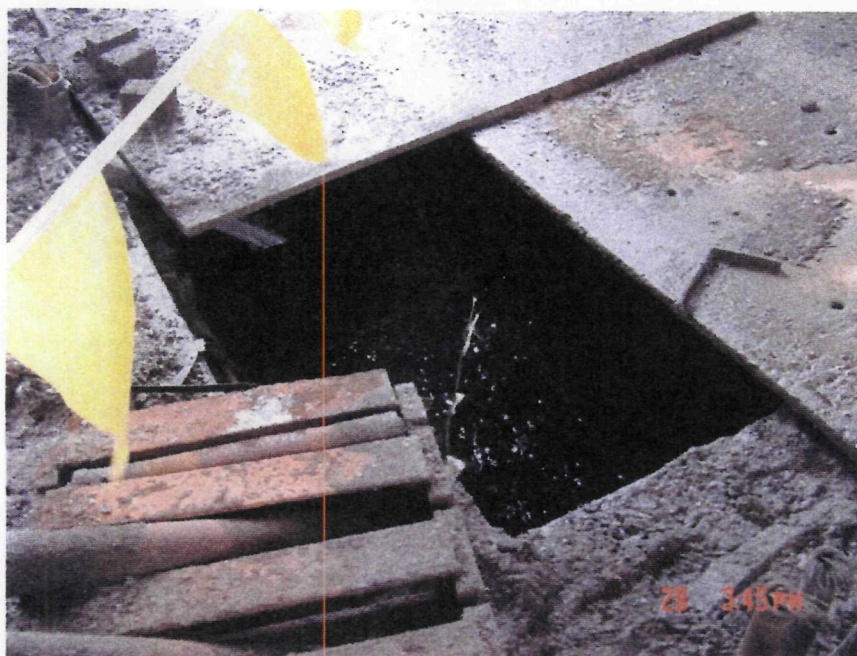
At pillars DB-9 and DB-10 along the northeast wall (Photo 07) of the building, a sump filled with thick oil and three drums was observed. Between pillars DB-29 and DB-30 along the northeast wall of Building 9, a room with 18 sets of fluorescent lights fixed to the ceiling was observed. Due to the age of the facility, the lights potentially contain PCBs.

SUBJECT: Pit containing oil in floor of old manufacturing area in Building 9 (No VOC readings observe with PID).

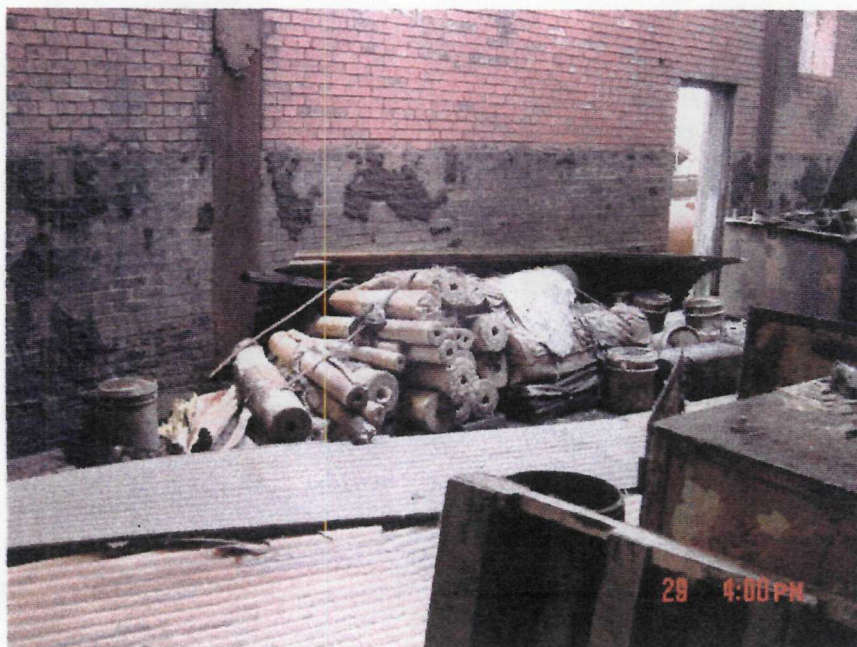
SUBJECT: Pillar Rolls of suspect asbestos insulation in a northeast room in Building 9

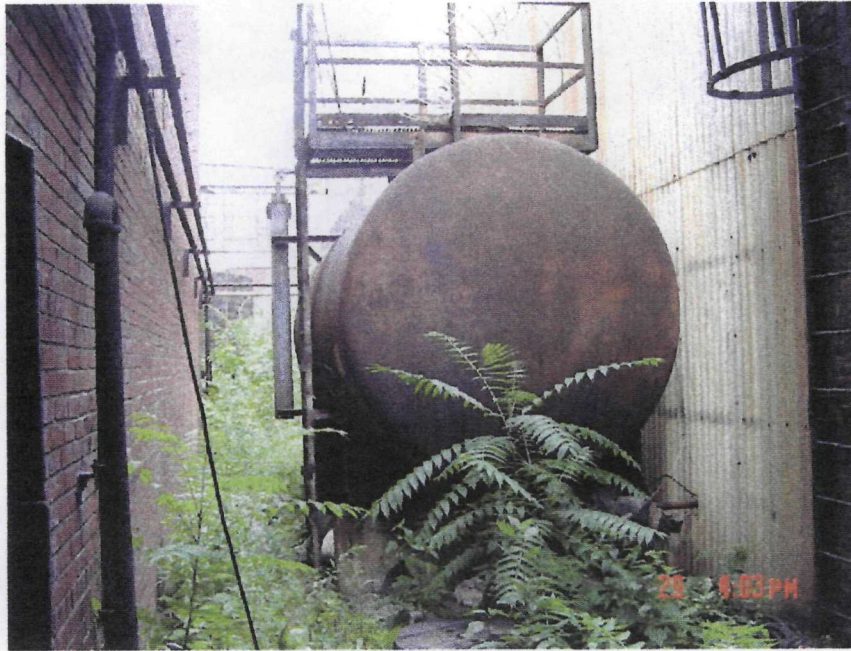
Next to this cluster of ASTs a transformer labeled PCBs was observed (Attachment C, Photo 16). Nearby to this cluster, and tucked in close to Building 9, was a reportedly empty 5,000-gallon AST labeled "hydraulic fluid" (Attachment C, Photo 09).

**SUBJECT:** Approx. 5,000-gallon, empty, hydraulic fluid AST along northeast exterior wall of Building 9.

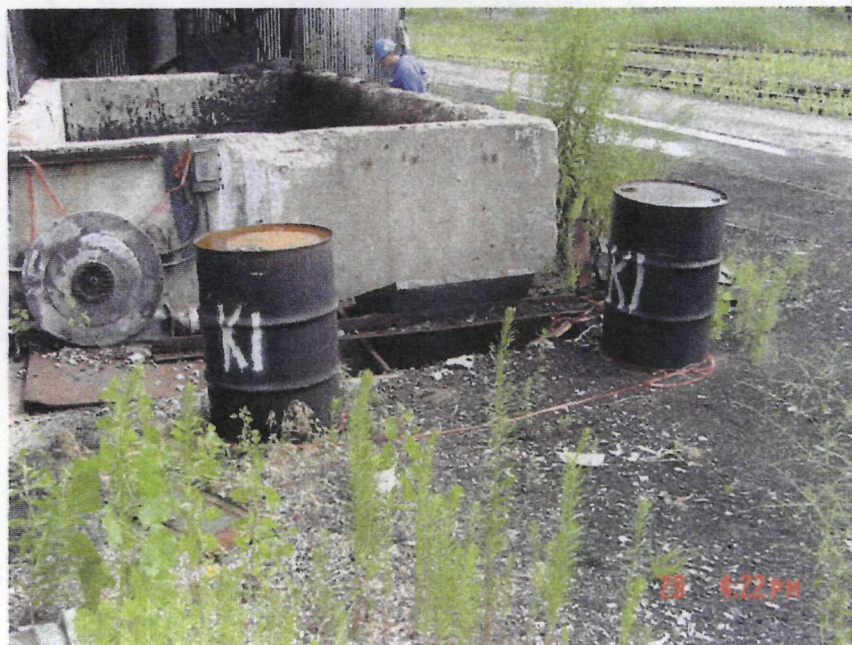
**SUBJECT:** Two empty, 55-gallon drums that formerly contained kerosene, labeled K-1, north of Building 9.

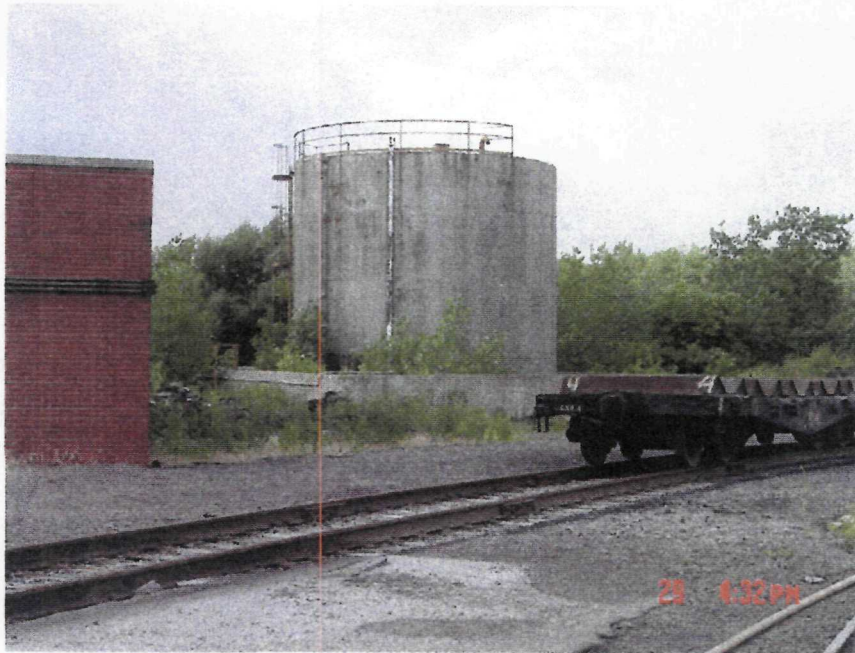
SUBJECT: **Approx. 30,000-gallon, fuel oil AST west of Building 9.**

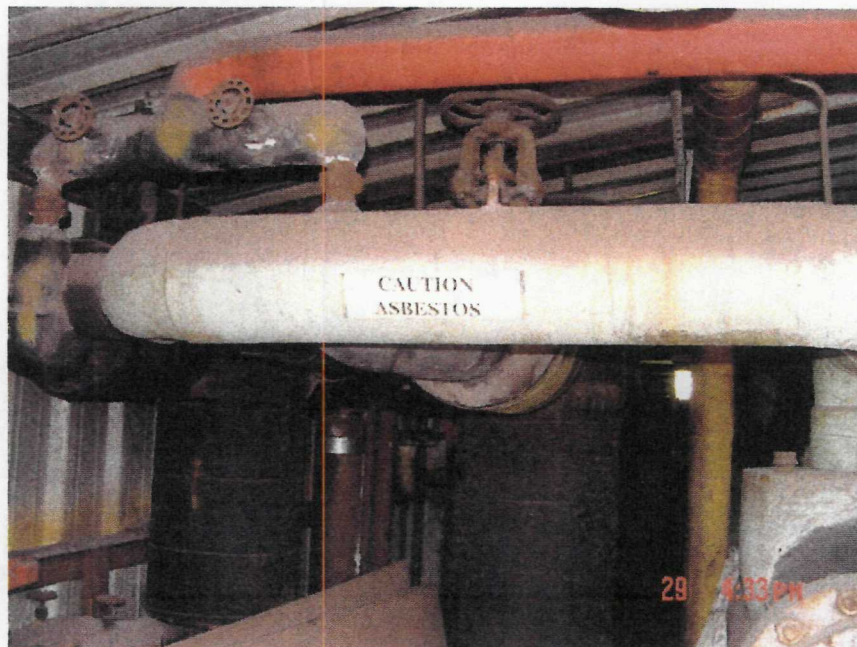
SUBJECT: Asbestos insulated pipeline in Building 9.

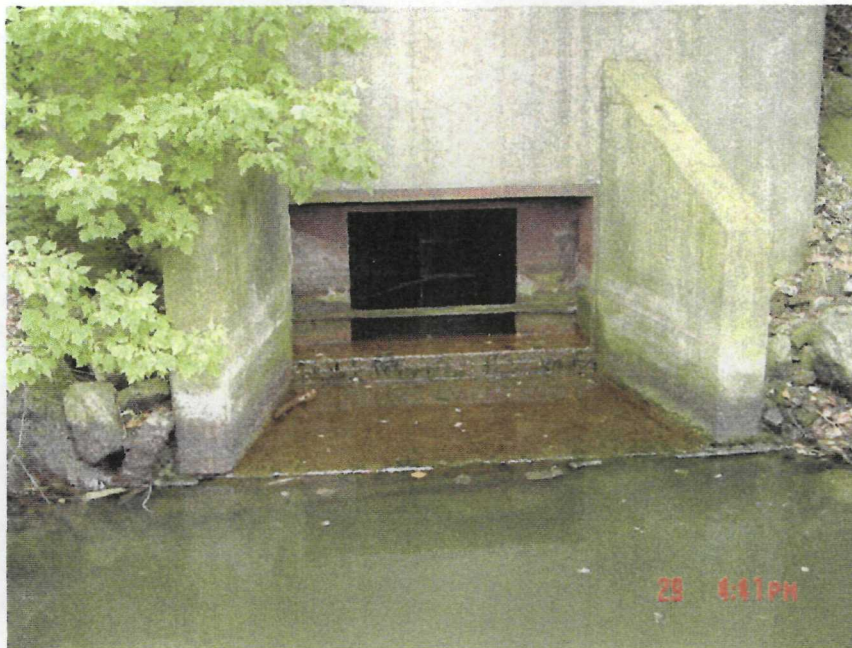
SUBJECT: South stormwater outfall as seen from walk way above containment area.

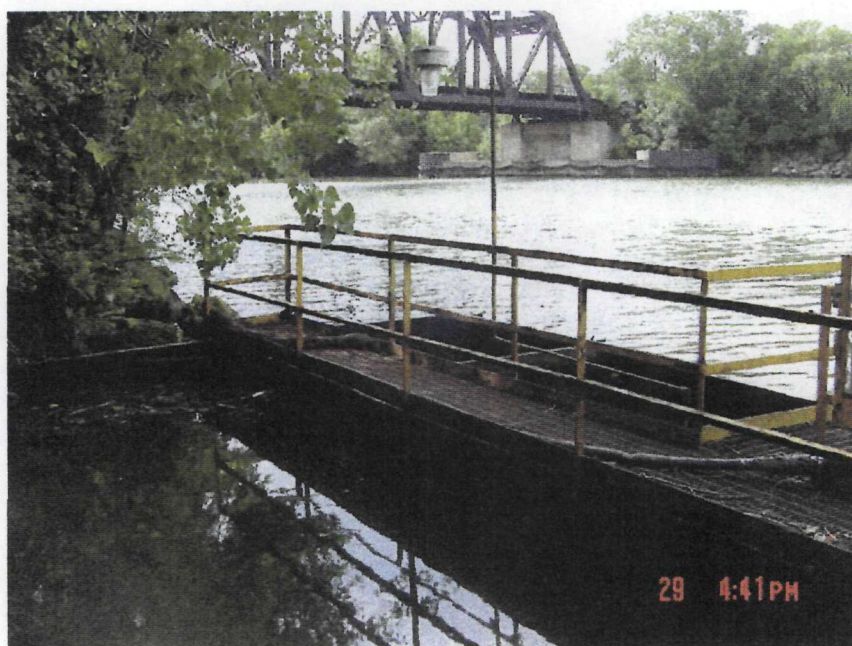
SUBJECT: South stormwater outfall and containment area with railroad bridge in background

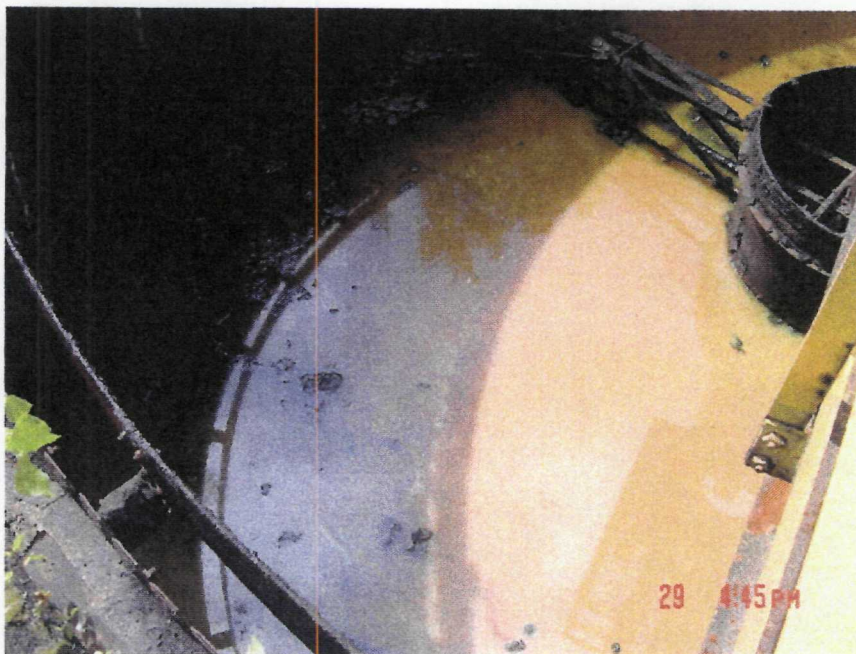
**SUBJECT:** View from above of contents of sand-filter clarifier, sheen observed on turbid, emulsified water.

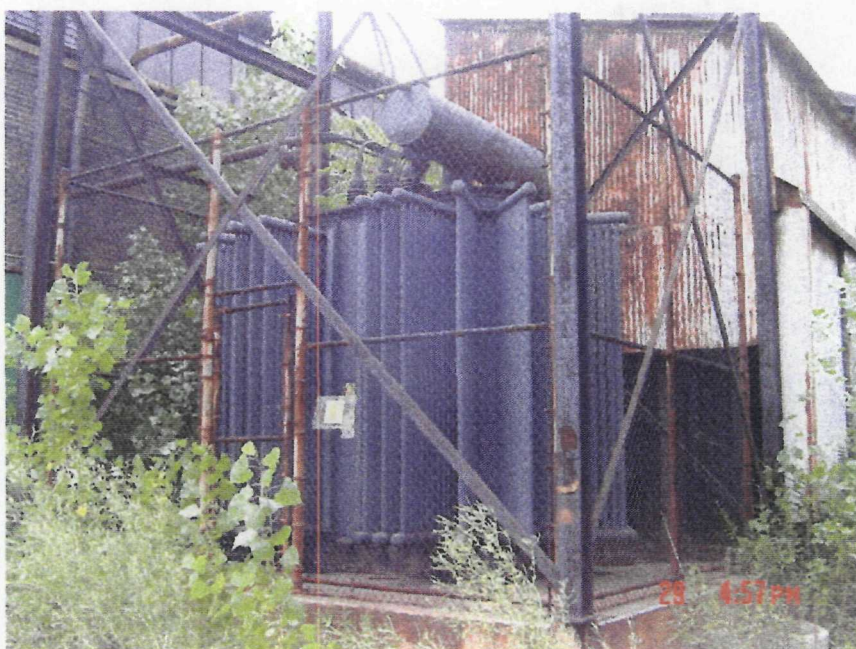
**SUBJECT:** PCB transformer behind (NE of) building 9A.

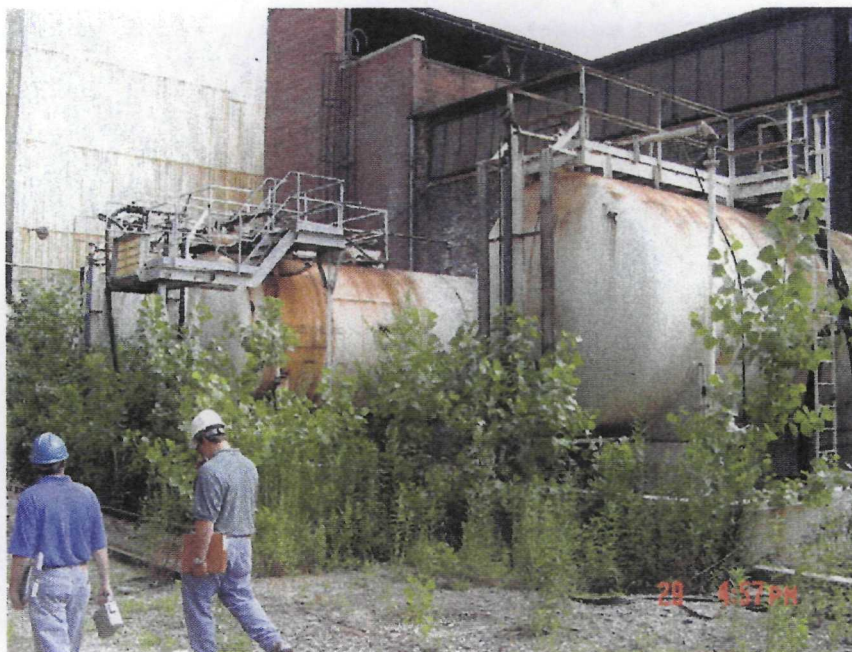
On the northeast side of Building 9A, transite sheeting was found lying on the ground near a cluster of five aboveground storage tanks (ASTs). Two of the ASTs (15,000 gallons each) were labeled "hydrochloric acid" (HCl); these ASTs did not appear to have been cleaned out (Attachment C Photo 17). One AST (5,000 gallons) was labeled "oil" and appeared empty. Another AST (15,000 gallons) was labeled "caustic (NaOH) 25%". The fifth AST (approximately 5,000-gallons) was labeled "caustic soda 25-85%".

SUBJECT: Three hydrochloric acid ASTs on northeast side of Building 9A.

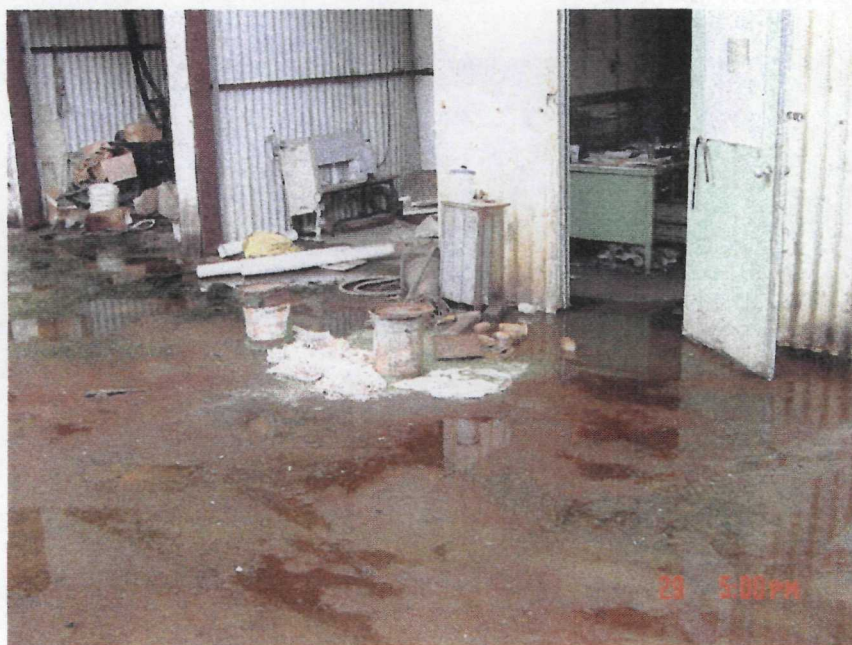
Following the inspection of Building 9, START continued the site inspection at Building 12, which housed the Rolling Mill. Upon entering the northwest end of Building 12, a 30-foot by 10-foot puddle of a reddish liquid was observed on the ground near some tanks of hydraulic oil (Attachment C, Photo 18). Beneath the pickle line was a sump filled with a reddish lube oil (Photo 19). The sump was apparently slowly filling with water, which was a reddish-gold color. At the southeast end of the pickle line more reddish lube oil pooled around a tank labeled "solvent for rust prevention" was noted.

SUBJECT: Red-colored material on floor at the northwest end of Building 12

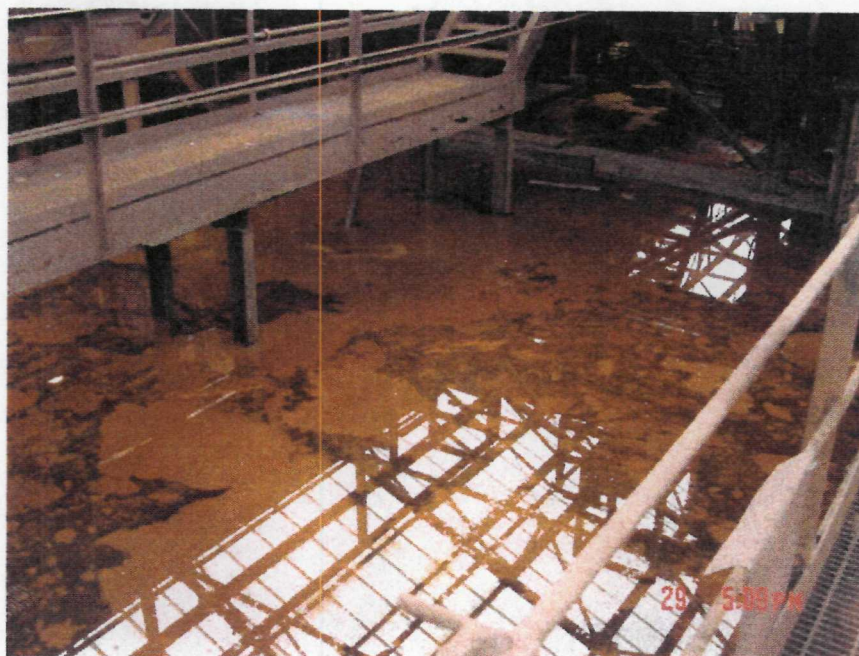
SUBJECT: Pickle line sump presently containing rainwater and pickling fluids; Building 12.

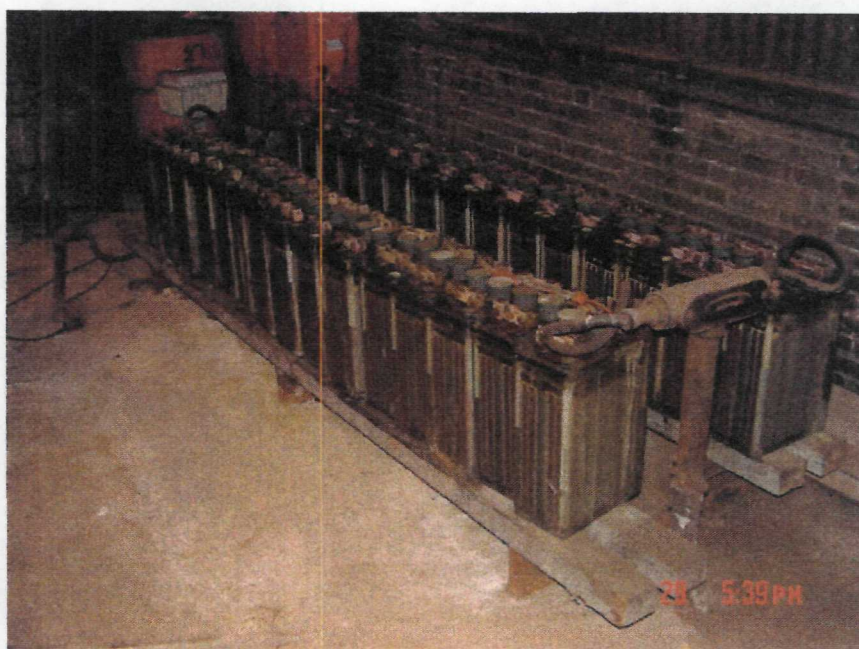
SUBJECT: Lead-acid batteries located in Building 7.

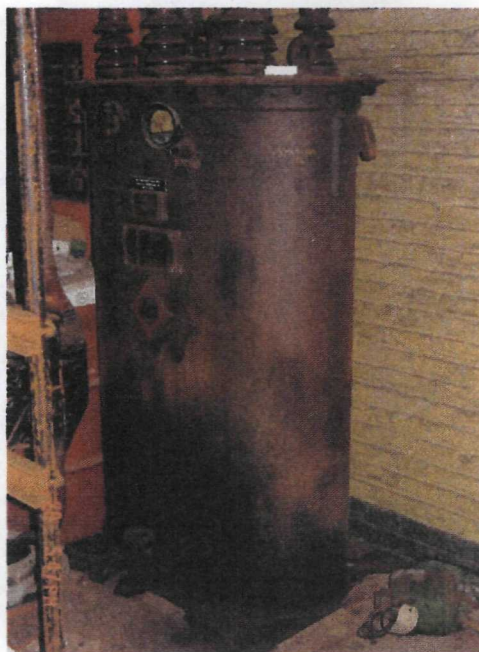
**SUBJECT:** Allis-Chalmers transformer, dated 1968, located in Building 7.

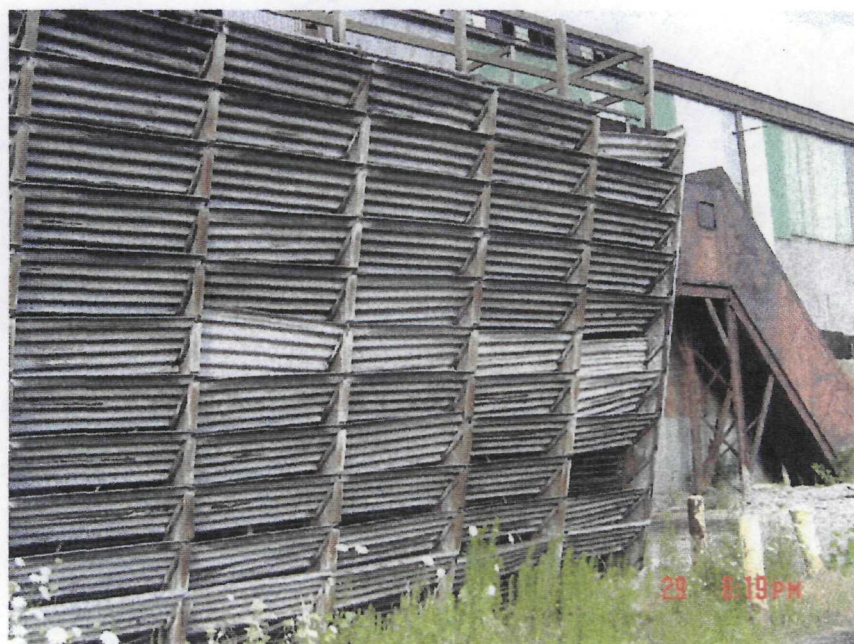
START completed the inspection of Building 9 with a walkthrough of the southwest edge of the building. A labeled propane cylinder was observed leaning against the building near the northwest end and a cooling tower with transite plating on the outside of it was noted (Attachment C, Photo 22).

**SUBJECT:** Cooling towers containing transite material located on northwest side of building 9.

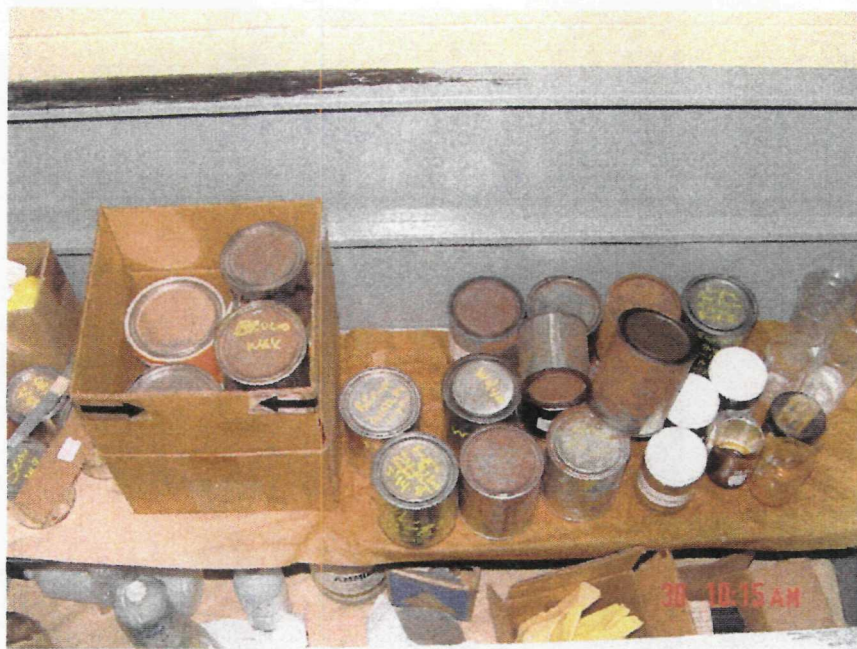
SUBJECT: Small quantities of laboratory chemicals located in a storage cabinet in Building 19 metals lab, 2<sup>nd</sup> floor

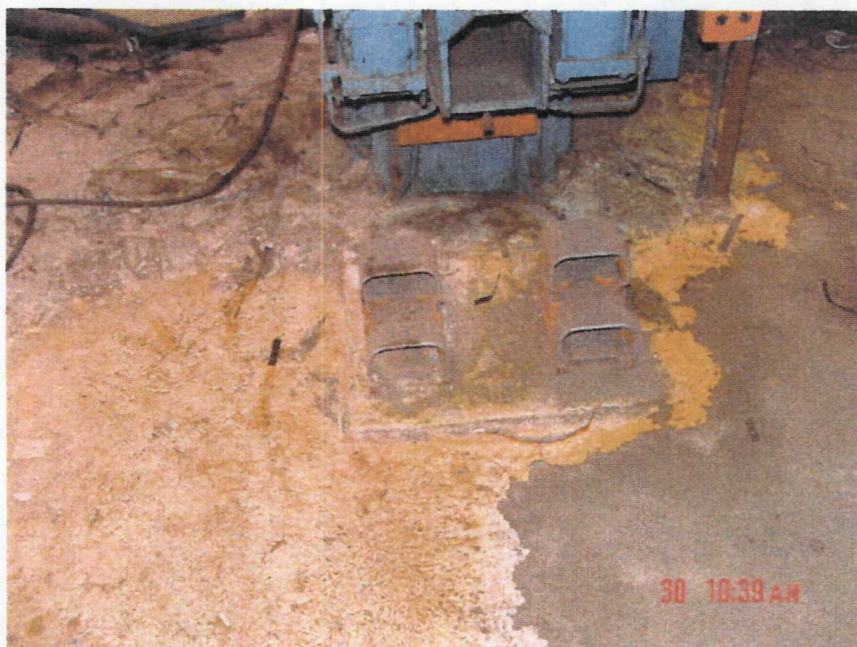
SUBJECT: Acid salts on floors surrounding process equipment in Building 19, 2<sup>nd</sup> floor

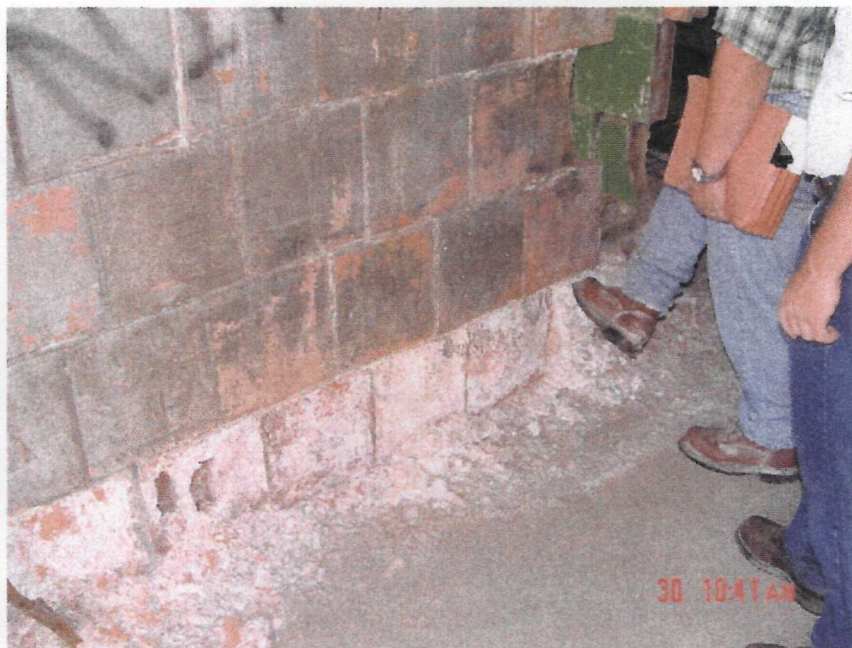
**SUBJECT:** Deteriorating concrete-block wall in Building 19, 2<sup>nd</sup> floor.

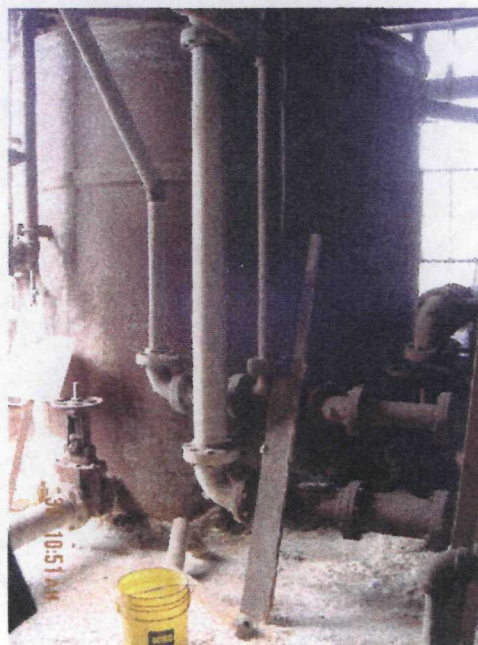
**SUBJECT:** Possible acid tank on east end of Building 19, 2<sup>nd</sup> floor

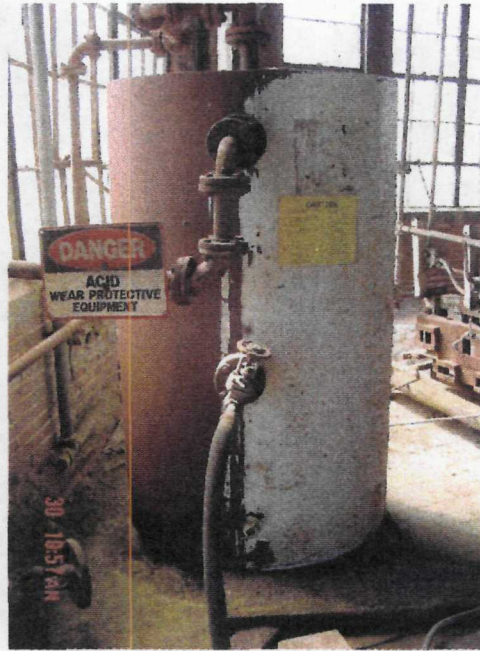
**SITE:** Acme Steel, Riverdale Facility      **DATE:** 30 July 2002 **PHOTO NO:** 27  
**SUBJECT:** Sulfuric acid tank in southeast end of Building 19, 2<sup>nd</sup> floor.  
**PHOTOGRAPHER:** START - D. Paxton
